# Evaluation Report 137

## Kirchner Model 70 Automatic Bale Wagon

A Co-operative Program Between

## KIRCHNER MODEL 70 AUTOMATIC BALE WAGON

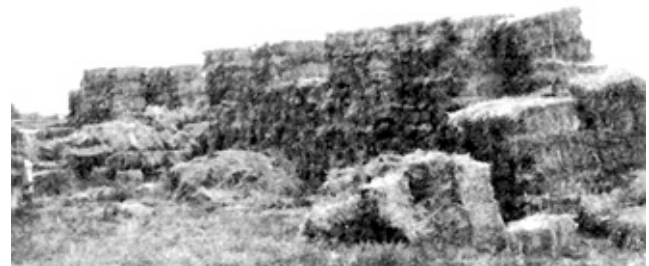
**Stack Quality:** Stack quality and durability depended on operator care, operator experience, bale quality, bale uniformity and selection of a suitable stack site. With proper care in baler operation, site selection and unloading, solid, durable stacks (FIGURE 3) were formed. If bales were of poor or variable quality, or if care was not taken in selecting a good stack site and in properly positioning bale loads within the stack, the stack usually collapsed within several days (FIGURE 4)

FIGURE 4. Poor Site Selection, Poor Bale Quality, or Careless Unloading Usually Resulted in Stack Collapse.

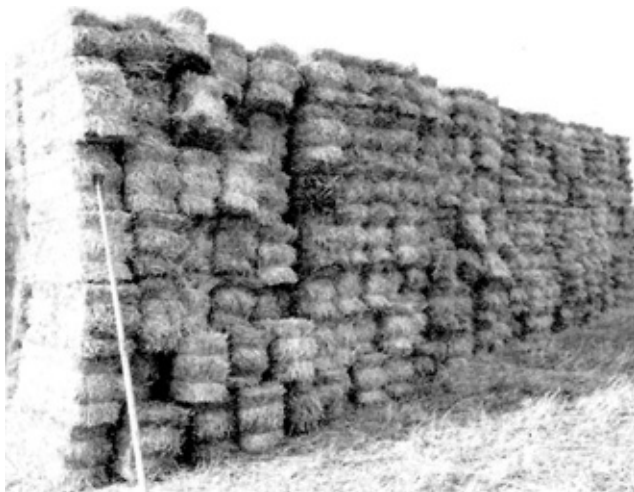
performance. Poorly formed bales on the bottom usually settled, resulting in stack collapse. Non-uniform bale lengths resulted in reduced stability and unsightly appearance on the right stack side, since all the bale length variations accumulated on this side (FIGURE 5).

FIGURE 5. Non-uniform Right Stack Side Resulting from Bale Length Variation.

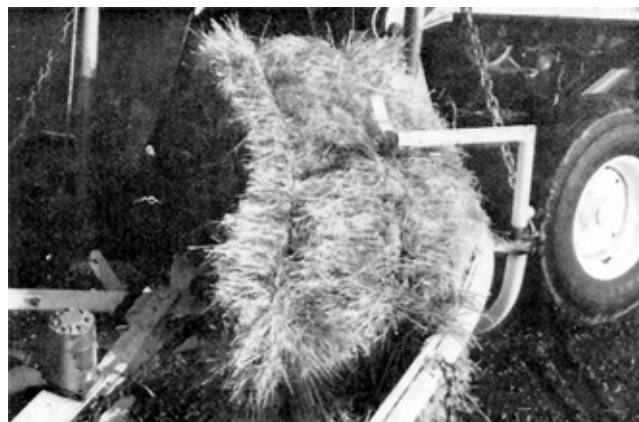
Bales had to bend as they moved up the loader (FIGURE 7). Although this presented no problem with normal bales, it often caused the outer twine to break on very dense bales. The use of a good quality twine reduced breakage; however, if the bale did not bend to conform to loader curvature, the table chain often cut the outer twine. Twine from broken or deformed bales became entangled in the loader and table chain sprockets. Twine buildup caused the loader chains to jam and stop (FIGURE 8) on several occasions.

FIGURE 7. Bending of Bale in the Loader.

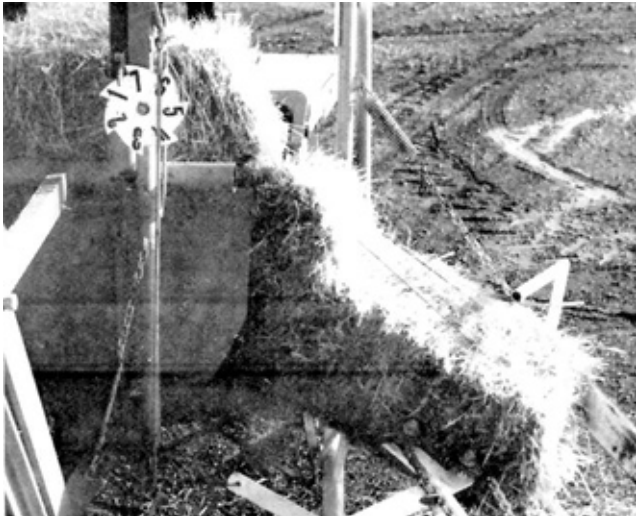
Sufficient bale density was required for proper entry into the bale chamber. Loose or poorly-formed bales jammed against the upper bale chamber sides (FIGURE 9). The bale could usually be cleared by quickly reversing the loader motors. If the loader motors were not reversed immediately, the bale broke or became badly deformed. If a broken or deformed bale was forced into the bale chamber it had to be cleared by hand. Hand removal was difficult, especially if this was the last bale of a lift or tier.

FIGURE 9. Loose Bale Wedged on Bale Chamber Side.

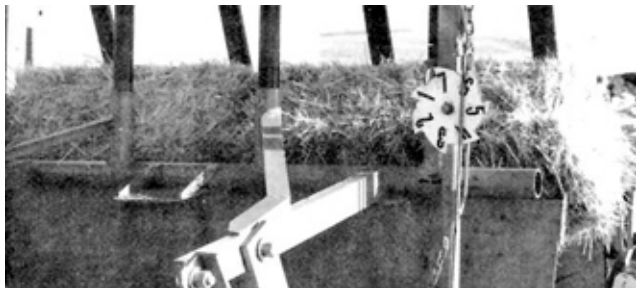
In rough fields, the first lift of bales in the bale chamber sometimes slipped edgeways (FIGURE 10). These bales usually straightened themselves on the next lift, however, an incoming bale sometimes jammed against the fallen bales, as it entered the bale chamber.

FIGURE 10. First Lift of Bales Slipped Sideways in Rough Fields.

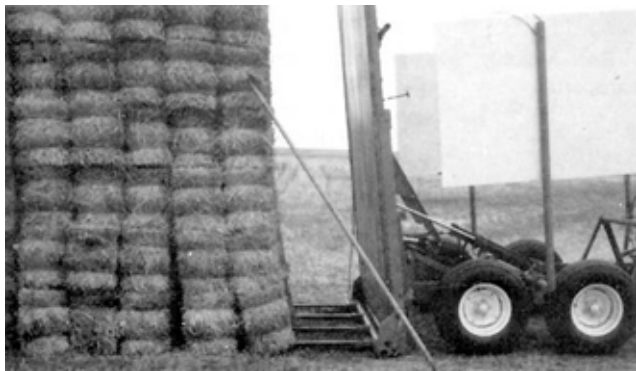
After extending and retracting the push-off feet, the operator had to move the tractor forward to pull the load deck fingers from beneath the stack. This sometimes pulled the outer lower bales away from the stack (FIGURE 13). It was difficult for the operator to notice this as visibility through the load deck was limited. Backing the wagon into the stack and repeating the push-off straightened the lower bale row, but on several occasions, props had to be placed against the lower bales. Modifications to increase push-off length are recommended to correct this problem.

FIGURE 13. Lower Bales Pulled Away From Stack by the Load Deck Fingers.

4. During the 1979 haying season, we are testing an experimental machine with a longer push off. If satisfactory, this will be incorporated into future production.

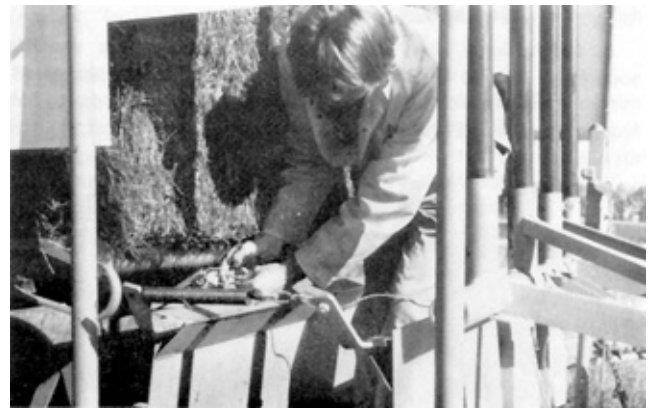
Caution had to be used when initiating and completing ties. Since the operator had to climb into the machine, the power take-off had to be disengaged and the tractor brakes set. Reaching under the partially raised load deck (FIGURE 15) to initiate or complete a tie was dangerous. Modification to include a mechanical load deck lock, to prevent possible injury, is recommended.

FIGURE 15. Reaching Under Partially Raised Load Deck to Initiate a Tie.

7. A mechanical lock on the load deck to improve operator safety when initiating and completing ties is under consideration.
8. Supplying a slow moving vehicle sign has been considered. However, our problem is finding a location where the sign would be visible while transporting and not conflict or be knocked off during stacking.
